Manhole Inspection Summary

Manhole # S02II2005MH

Location Address: **3100 Fallstaff Manor**

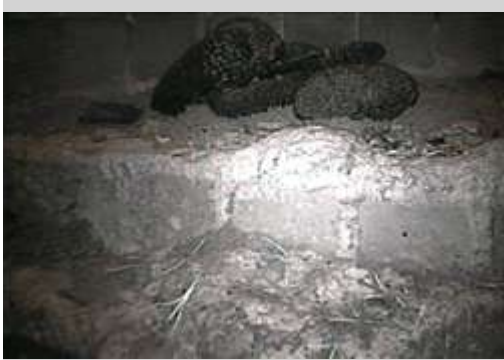
Defect

Condition: ☐ Sound ☐ Cracked ☐ Root Intrusion ☐ Deteriorated ☐ Leaks ☒ **Debris**

debris on bench

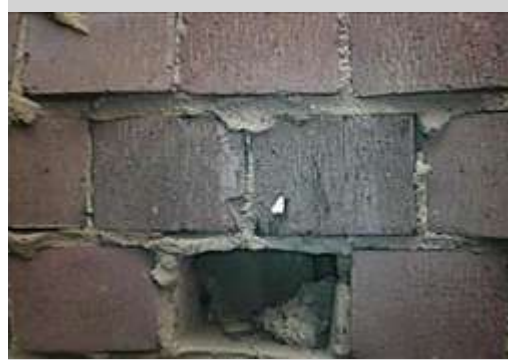
Defect

Condition: ☐ Sound ☐ Cracked ☐ Root Intrusion ☒ **Loose Brick** ☐ Deteriorated

missing brick

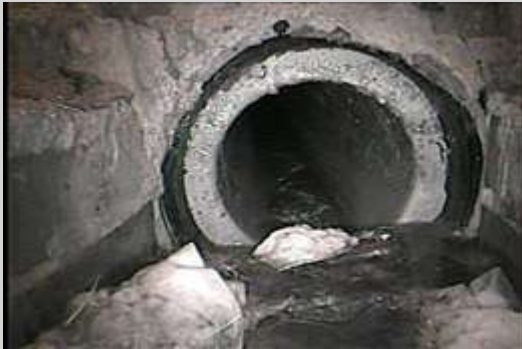
8 in. Circular Gravity Sewer Pipe Out @ 12 O'Clock

Invert Depth: **11.70** (ft.) Flow Characteristics: **Slow**

Infiltration: **None** Pipe Seal Cond: **Sound**

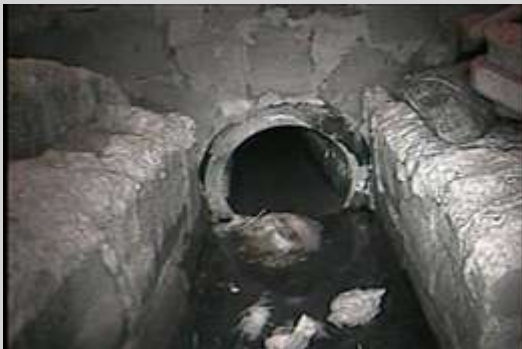
6 in. Circular Gravity Sewer Pipe In @ 5 O'Clock

Invert Depth: **11.60** (ft.) Flow Characteristics: **None**

Infiltration: **None** Pipe Seal Cond: **Sound**

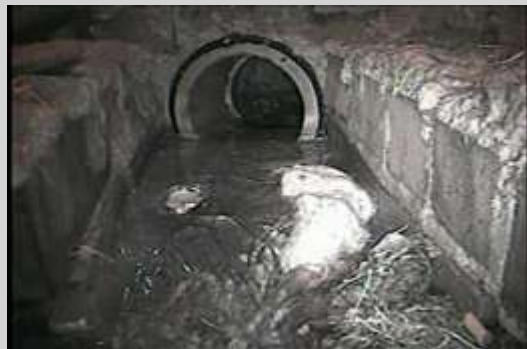
6 in. Circular Gravity Sewer

Invert Depth: **11.55** (ft.) Flow Characteristics: **Slow**

Infiltration: **None**

Pipe Seal Cond: **Sound**
